# BEACH EROSION CONTROL REPORT ON COOPERATIVE STUDY OF CONNECTICUT

## AREAS 8 AND 11

SAUGATUCK RIVER  
TO  
BYRAM RIVER

JULY 27, 1956

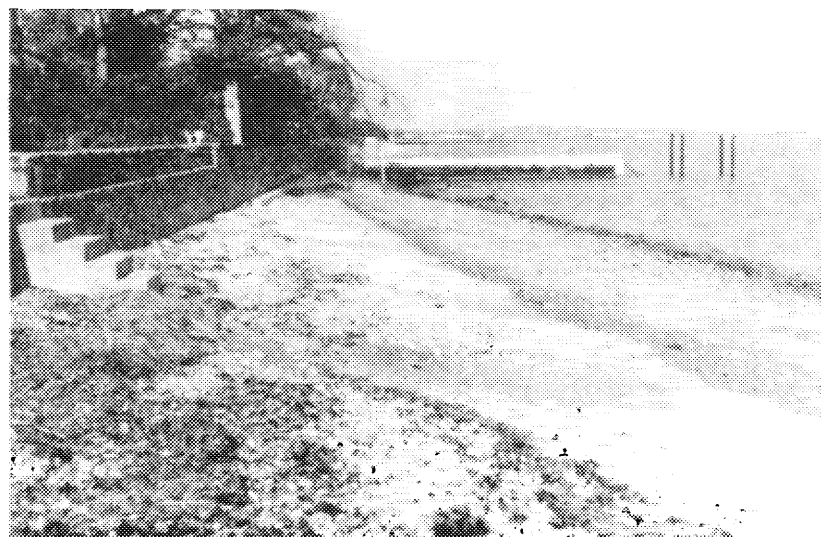
FIG. 3. SHORE HAVEN, NORWALK. Oct. 19, 1948. North  
from solid pier which impounds beach material.

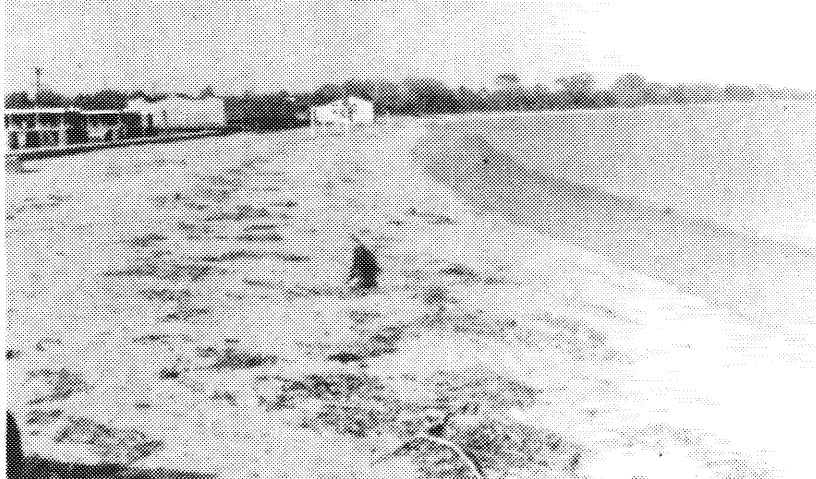
FIG. 1. CALF PASTURE BEACH PARK, NORWALK. Oct. 19, 1948.  
North from stone groin at south end of bathing beach.

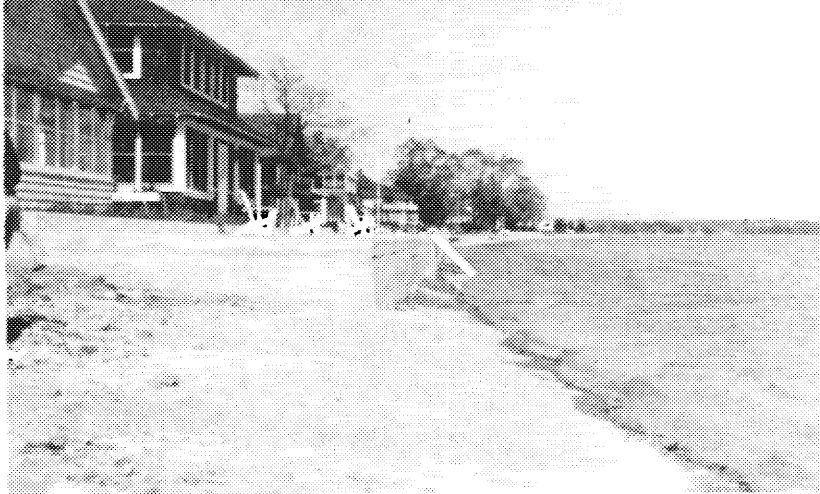
FIG. 1. HARBORVIEW, NORWALK. Oct. 19, 1948. Residences on low beach close to the water's edge.

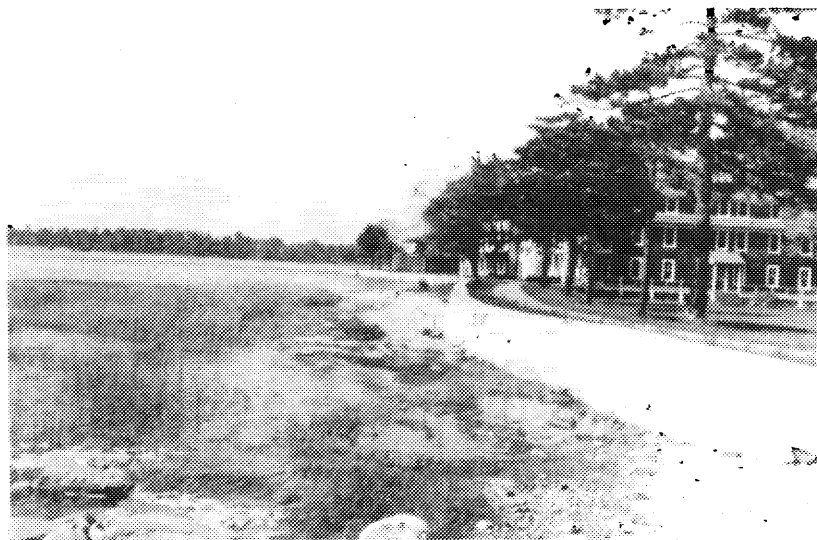
FIG. 2. MANRISSA ISLAND, NORWALK. Oct. 19, 1948. Low wall along south shore of Island.

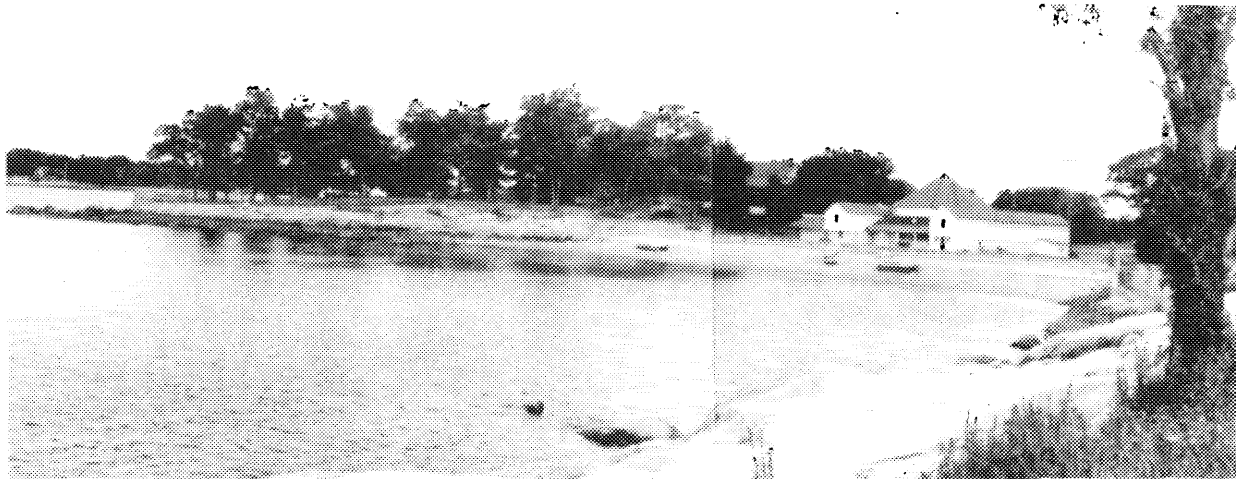
FIG. 1. ROTON POINT PARK, NORWALK. Sept. 24, 1948. Sandy pocket beach between rock outcrops.

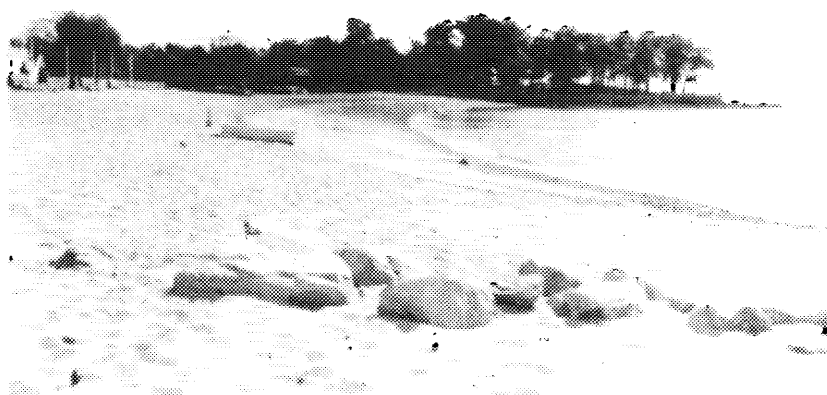
FIG. 2. WEST OF ROTON POINT, NORWALK. Sept. 24, 1948. Bailey Beach adjacent to point. Wee Burn Beach Club in foreground.

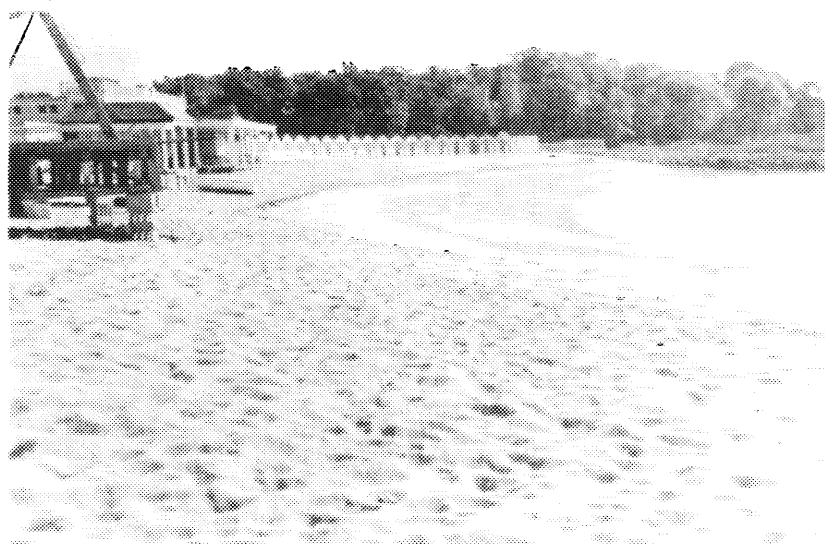
FIG. 3. BUTLER ISLAND, DARIEN. Sept. 24, 1948. Sandy pocket beach at Tokeneke Club.

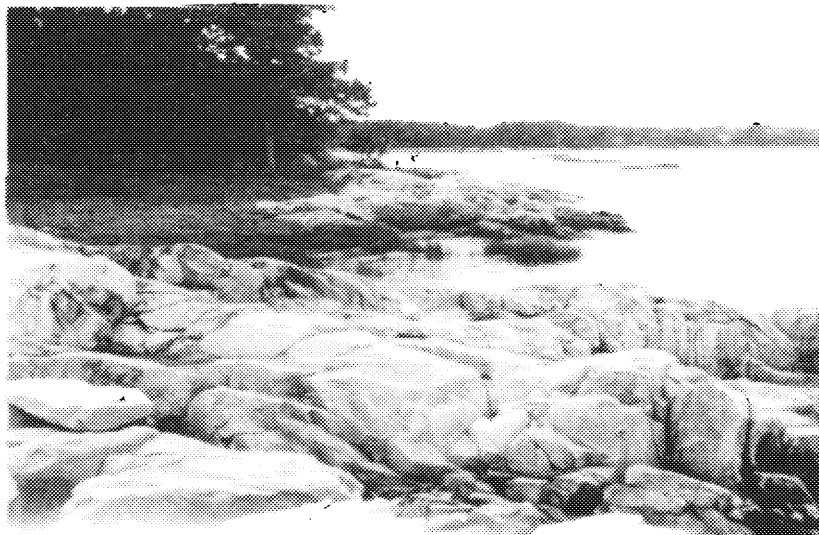
FIG. 2. GREAT ISLAND, DARIEN. Sept. 23, 1948. Irregular  
rocky east shore of island.

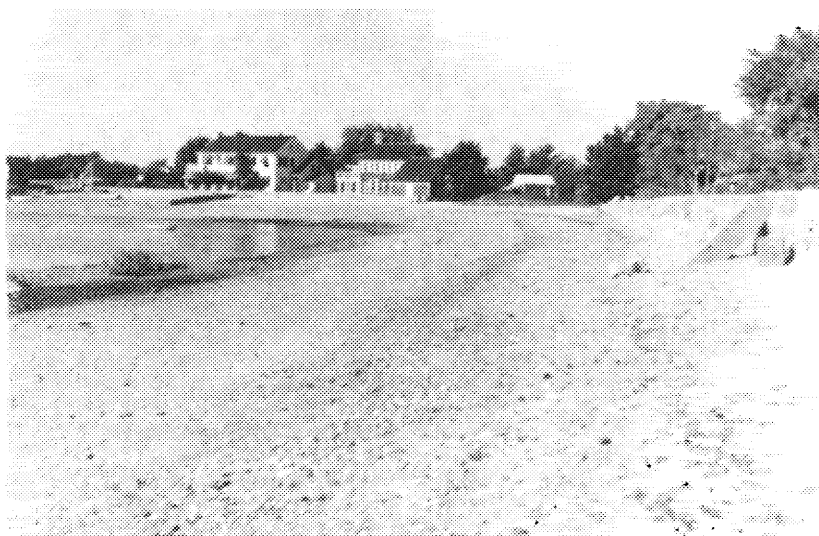
FIG. 3. NOROTON NECK, DARIEN. Sept. 23, 1948. Sandy  
east shore at mouth of Darien River opposite Peartree  
Point.

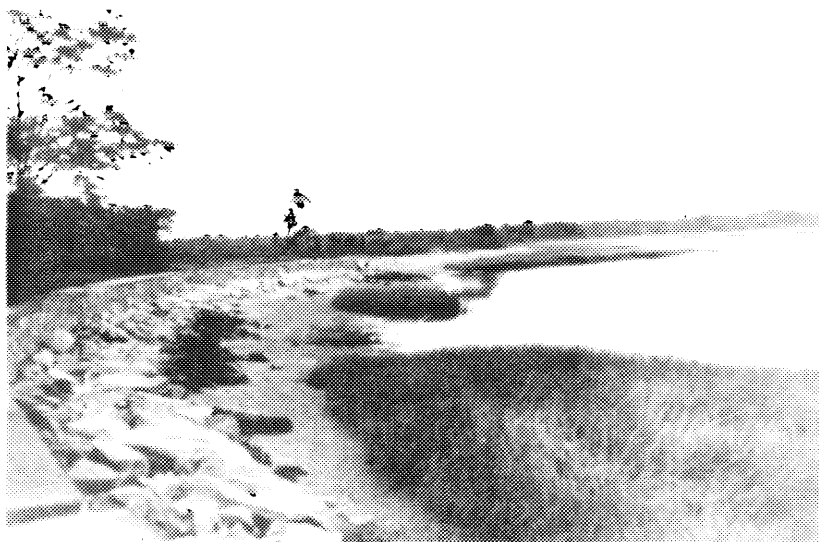
FIG. 2. COVE ISLAND, STAMFORD. Sept. 22, 1948. East shore looking towards Holly Pond entrance.

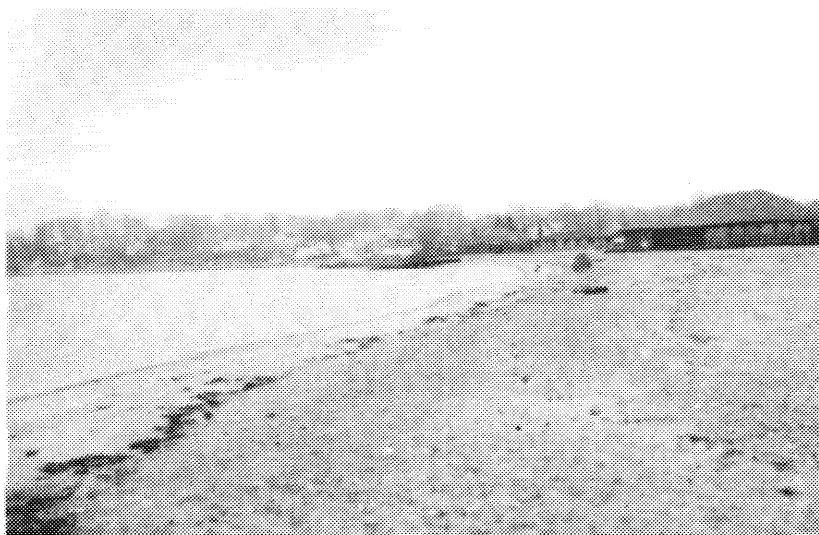
FIG. 3. WEST BEACH, STAMFORD. Apr. 21, 1955. South along public bathing beach.

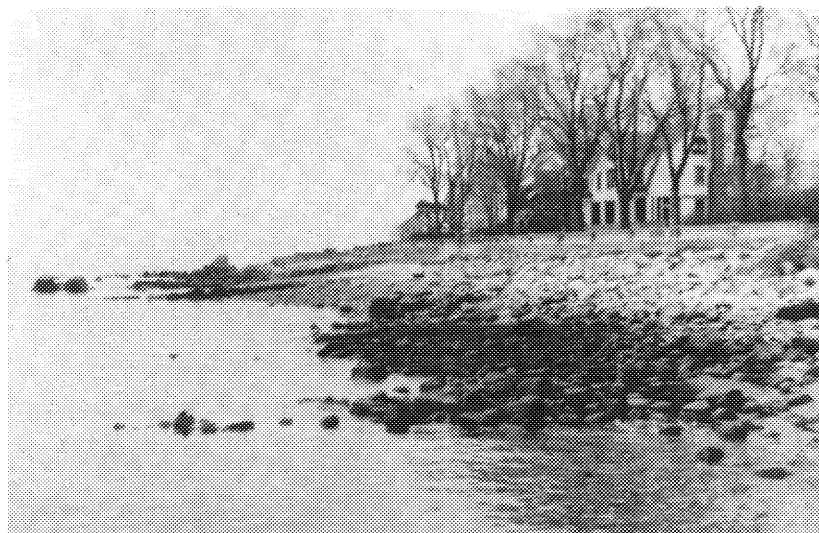
FIG. 2. EAST SHORE SHIPPAN POINT. Apr. 21, 1955.  
Coarse shore south of Shippan Avenue.

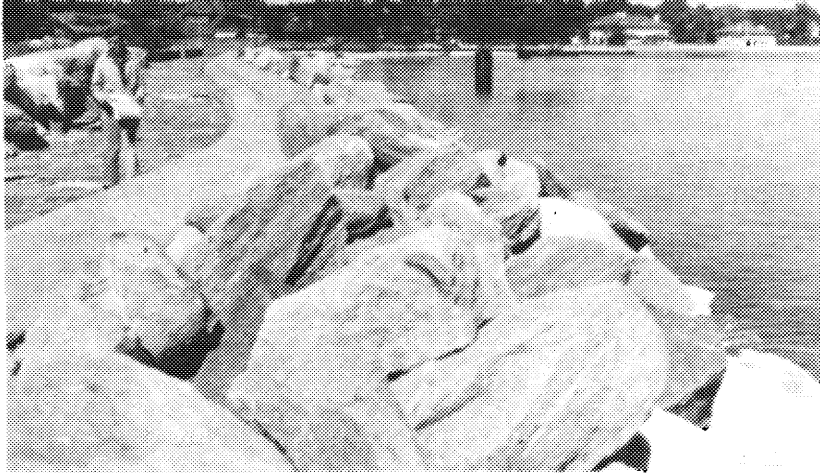
**FIG. 1. EAST SHORE SHIPPAN POINT.** Sept. 22, 1948.  
Heavy riprap fronting wall at tip of point.

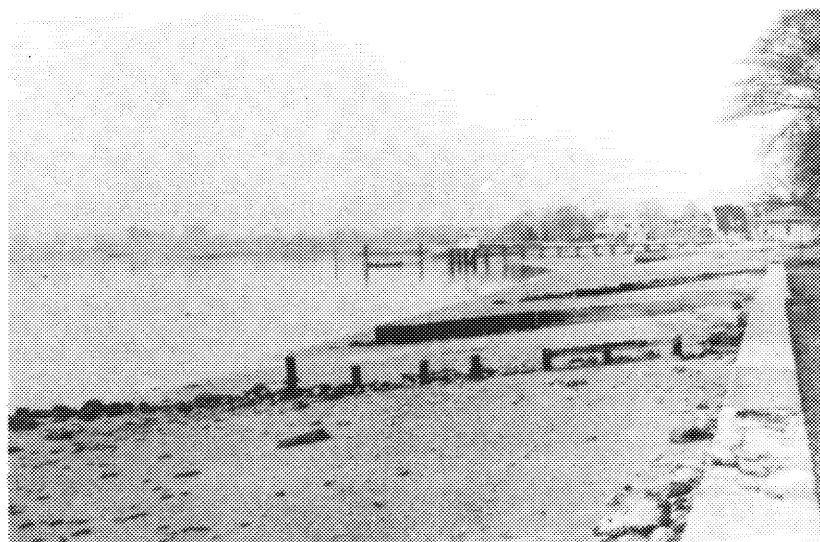
**FIG. 2. WEST SHORE SHIPPAN POINT.** Apr. 21, 1955. Shore  
south of Stamford Yacht Club.

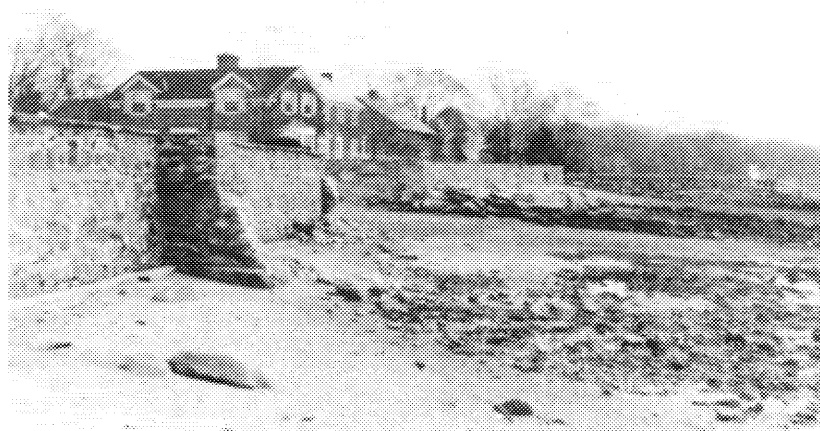
**FIG. 3. WEST SHORE SHIPPAN POINT.** Apr. 21, 1955.  
Coarse shore near East Branch Channel entrance.

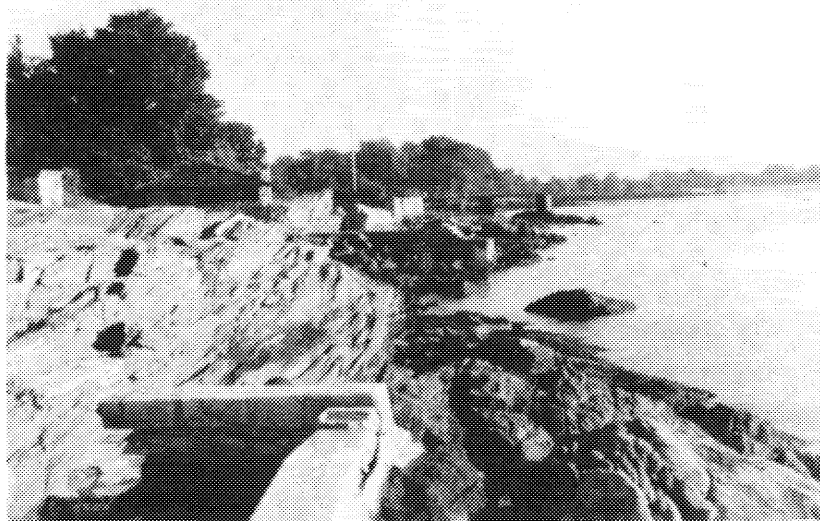
**FIG. 2. OLD GREENWICH, GREENWICH.** Sept. 22, 1948. Rocky east shore adjacent to Greenwich-Stamford boundary.

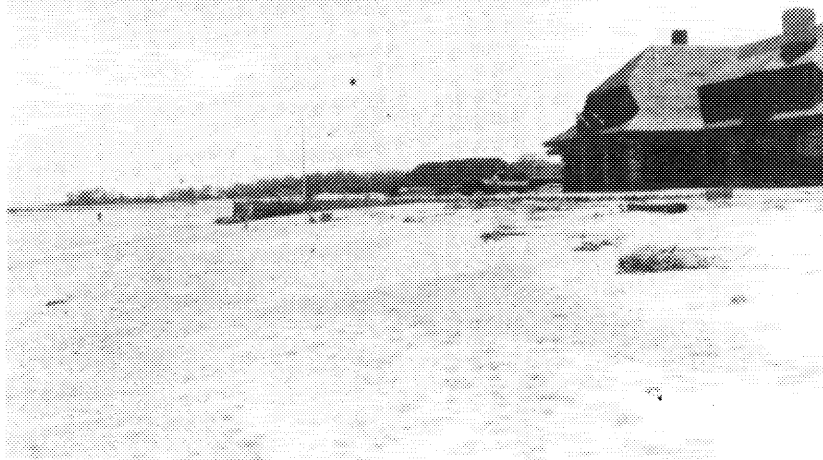
**FIG. 1. GREENWICH POINT, GREENWICH. May 2, 1955.**  
**Northerly end of public bathing beach.**

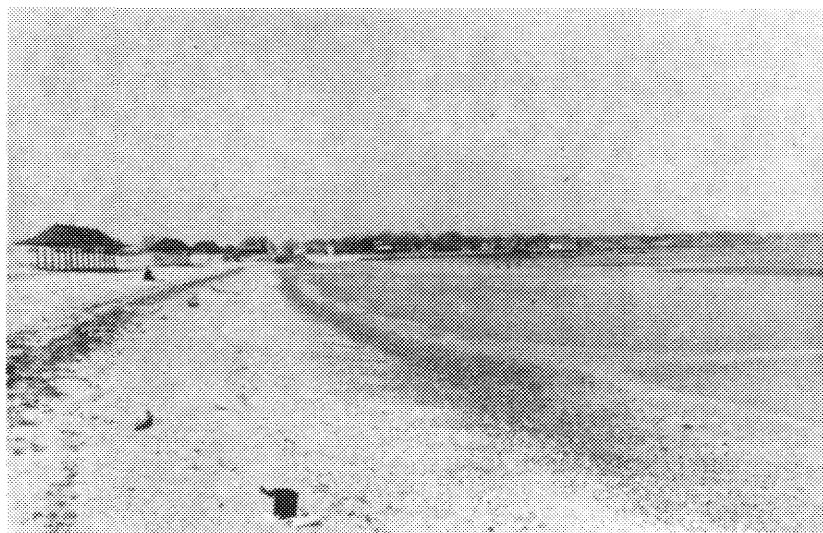
**FIG. 2. GREENWICH POINT, GREENWICH. May 2, 1955.**  
**Southerly end of public bathing beach.**

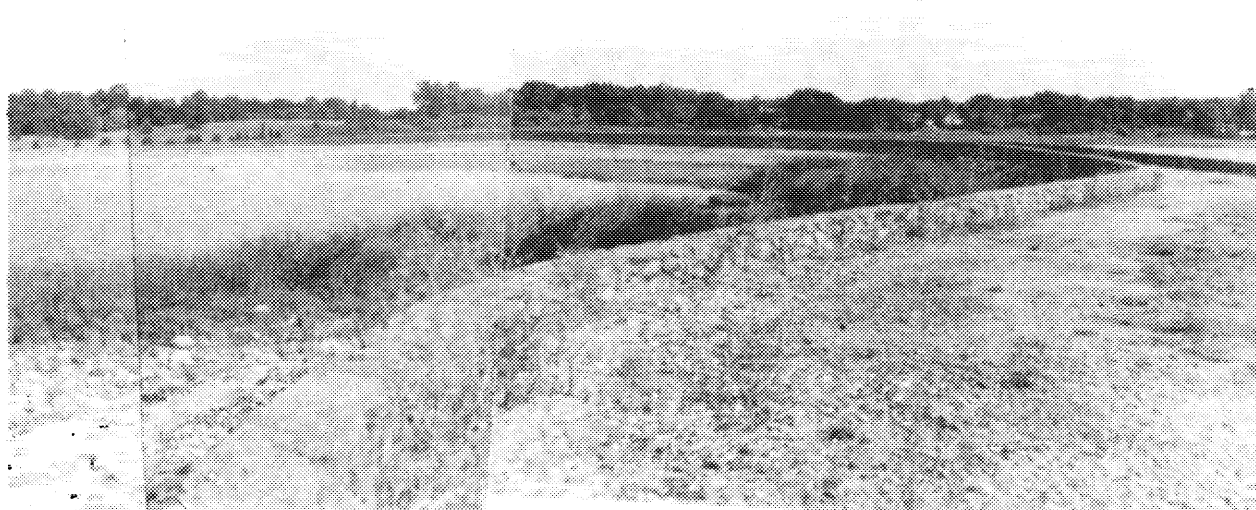
**FIG. 3. ELIAS POINT, GREENWICH. Sept. 21, 1948.** Sandy  
**pocket beach at west side of point.**

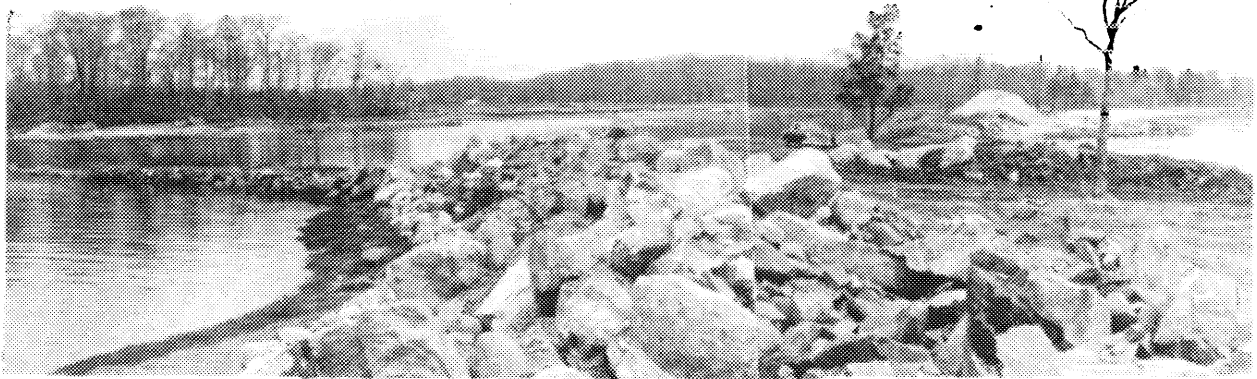
FIG. 1. MEAD POINT, GREENWICH. May 3, 1955. Breakwater and fill connecting point to Brush Island, at left, form a small harbor.

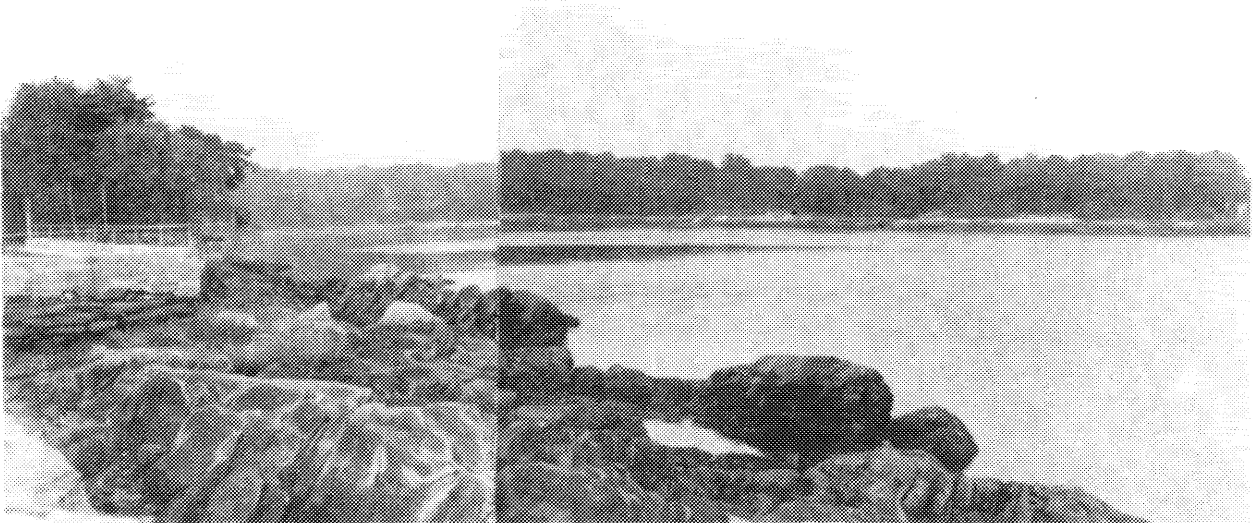
FIG. 2. STEAMBOAT ROAD POINT, GREENWICH. Sept. 20, 1948. Rocky east shore of outer tip of point.

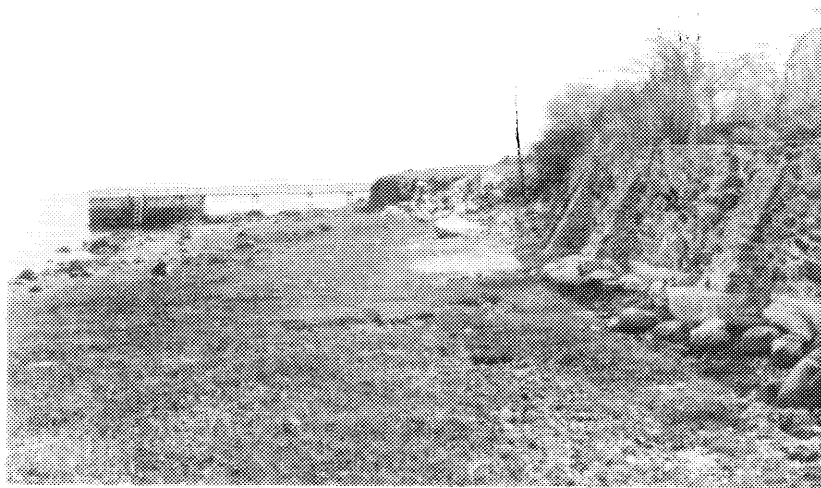
FIG. 3. FIELD POINT, GREENWICH. May 3, 1955. Looking south along east shore below Round Island.

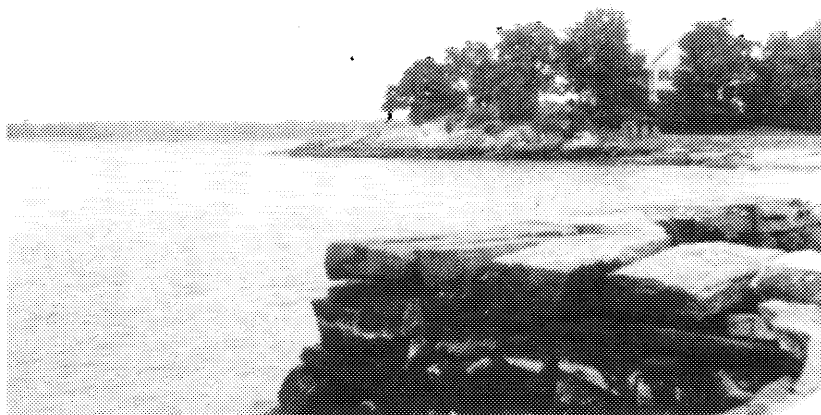
FIG. 1. BELLE HAVEN, GREENWICH. Aug. 20, 1948. Rocky south tip of Belle Haven.

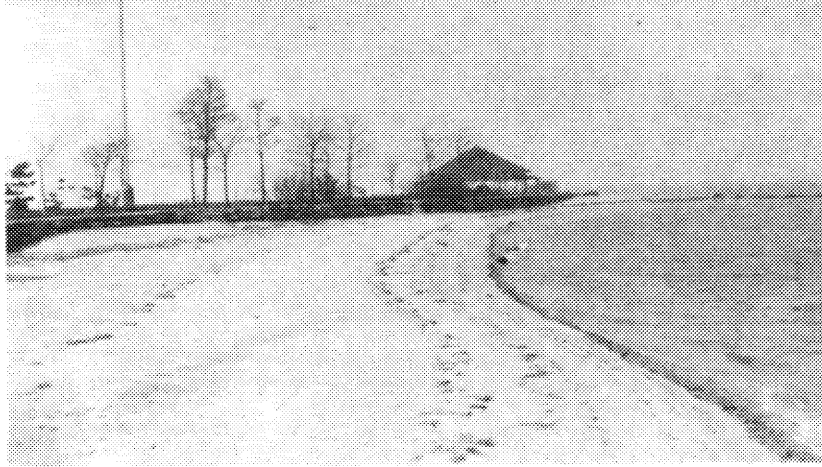
**FIG. 1. LITTLE CAPTAIN ISLAND, GREENWICH. May 4, 1955.**  
Sandy public bathing beach along north side of island.
